Manhole Inspection Summary

Manhole # S65Q__009MH

Insp Date: **3/6/08 9:23 AM**

Location Address: **6131 Cardiff Ave.**

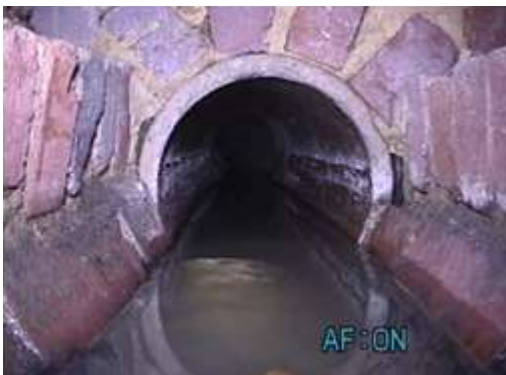
Defect 2

Void visible crack 3:00 incoming 6 O'Clock

Pipe Height: **8.4** (in.) Rod and Bar (Angled)
Pipe Material: **Clay** ☐ Pipe Lined
Invert Depth: **8.92** (ft.) Flow Characteristics: **Slow**
Deposits: ☒ None ☐ Mud ☐ Sludge ☐ Debris ☐ Grease
Silt Depth: (in.) Deposits Extent:
Infiltration: **Evidence** Pipe Seal Cond: **Broken**

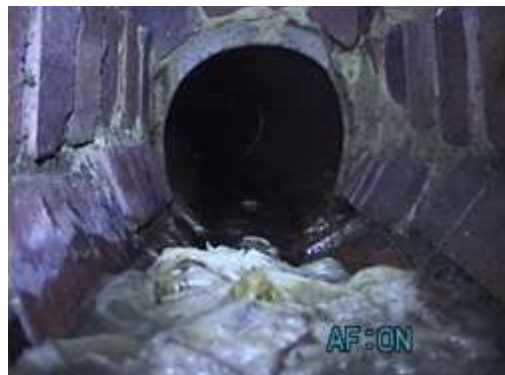
Defect 1

Cracked pipe seal 1:00-5:00 outgoing 12 O'Clock

Pipe Height: **8.4** (in.) Rod and Bar (Angled)
Pipe Material: **Clay** ☐ Pipe Lined
Invert Depth: **9.00** (ft.) Flow Characteristics: **Slow**
Deposits: ☒ None ☐ Mud ☐ Sludge ☐ Debris ☐ Grease
Silt Depth: (in.) Deposits Extent:
Infiltration: **Evidence** Pipe Seal Cond: **Cracked**

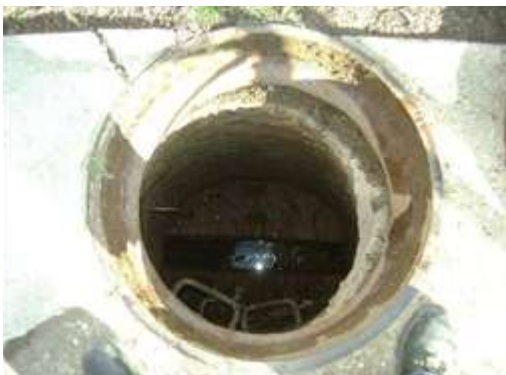
Defect 3

Frame Offset: **3** (in.) Condition: ☒ Sound ☐ Cracked ☐ Leaks

Offset frame defect

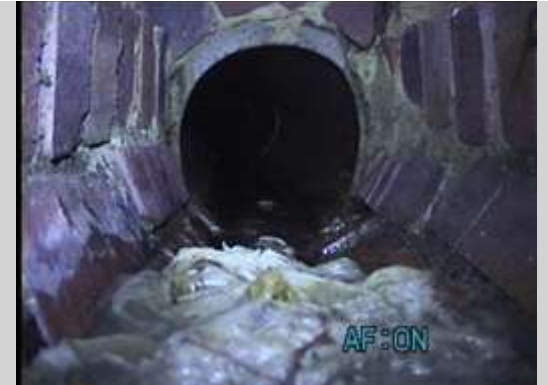
12 O'Clock Outflow

8 in. Circular Gravity Sewer
Pipe Out @ 12 O'Clock

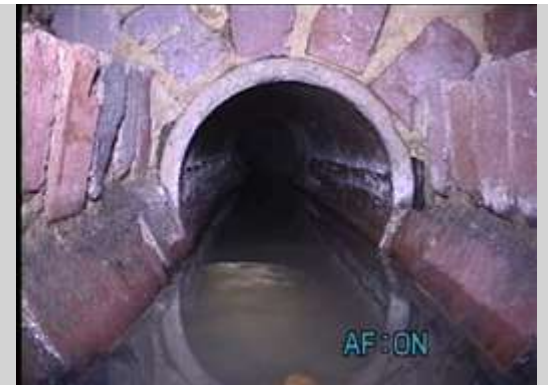
6 O'Clock Inflow

8 in. Circular Gravity Sewer
Pipe In @ 6 O'Clock
